# Manhole Inspection Summary

Manhole # S21AA2016MH

**Location** Address: **1211 MATTFELDT AVE** Cross Street: **NORTHERN PKWY**

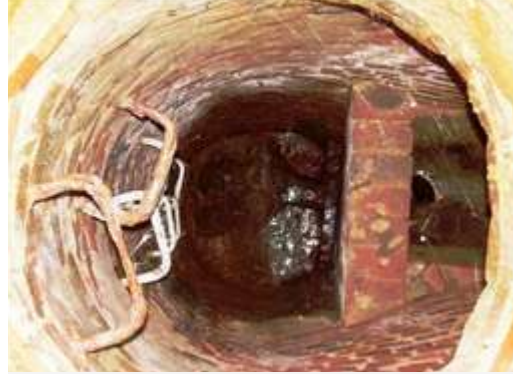
Top View

Corroded steps. Bench debris.

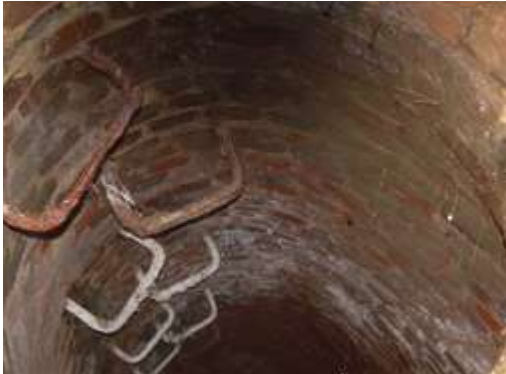
Defect

**Chimney / Frame Adjustment** ☒ Exists Material: **Brick** ☐ Parged Height: **12** (in.)  
Condition: ☐ Sound ☐ Cracked ☐ Root Intrusion ☐ Loose Brick ☒ **Deteriorated**  
Infiltration: ☐ None ☒ **Joint** ☐ Cracks ☒ **Mortar** ☐ Roots ☒ **Wall**

**Corbel** Material: **Brick** ☐ Parged Type: **Concentric/Eccentric**  
Condition: ☐ Sound ☐ Cracked ☒ **Root Intrusion** ☐ Loose Brick ☐ Deteriorated  
Infiltration: ☐ None ☐ Joint ☐ Cracks ☒ **Mortar** ☒ **Roots** ☒ **Wall**

**Barrel** Material: **Brick** ☐ Parged  
Shape: **D-Shape** Diameter: **48** (in.) Length: **60** (in.)  
Condition: ☐ Sound ☐ Cracked ☒ **Root Intrusion** ☐ Loose Brick ☒ **Deteriorated**  
Infiltration: ☐ None ☐ Joint ☐ Cracks ☒ **Mortar** ☒ **Roots** ☒ **Wall**

Adjustment deterioration and infiltration.  
Corbel root intrusion and infiltration.  
Barrel infiltration.

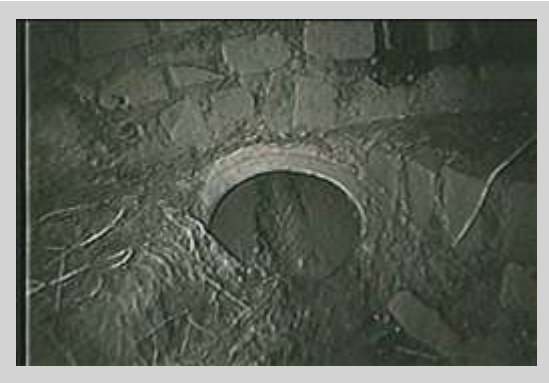
### 8 in. Circular Gravity Sewer Pipe Out @ 12 O'Clock

**Bench** ☒ Exists Material: **Brick** ☐ Parged ☐ Debris (not Condition related)  
Condition: ☐ Sound ☐ Cracked ☒ **Root Intrusion** ☐ Deteriorated ☐ Leaks ☐ Debris

**Channel** Material: **Brick** ☐ Parged ☐ Debris (not Condition related)  
Channel Exposure: **Fully Open** Junc Dist: **0** nearest .5 ft. Azimuth:  
Condition: ☐ Sound ☐ Cracked ☒ **Root Intrusion** ☐ Deteriorated ☐ Leaks ☐ Debris

Bench and Channel root intrusion.

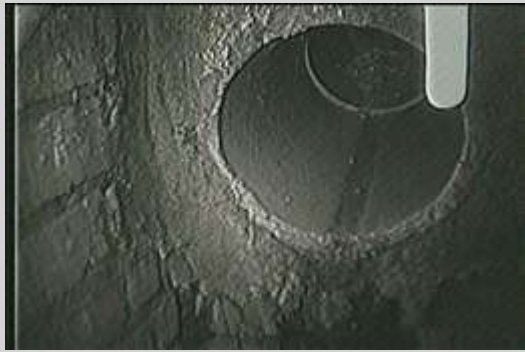
Pipe In @ 6 O'Clock

Infiltration: **Evidence** Pipe Seal Cond: **Roots**

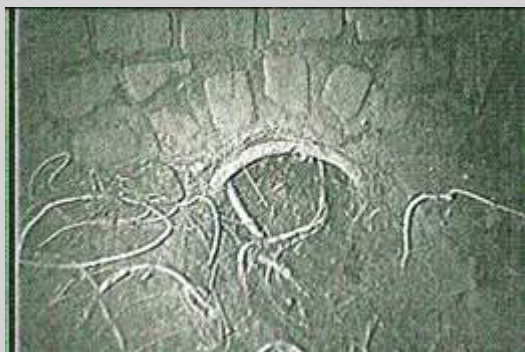
Pipe In @ 9 O'Clock

Barrel deterioration, root intrusion and infiltration.

Infiltration: **Evidence** Pipe Seal Cond: **Roots**
